**Pinnacle Mountain State Park**  
Existing Visitor Center Assessment  
Little Rock, Arkansas

August 7, 2023  
Revised October 12, 2023

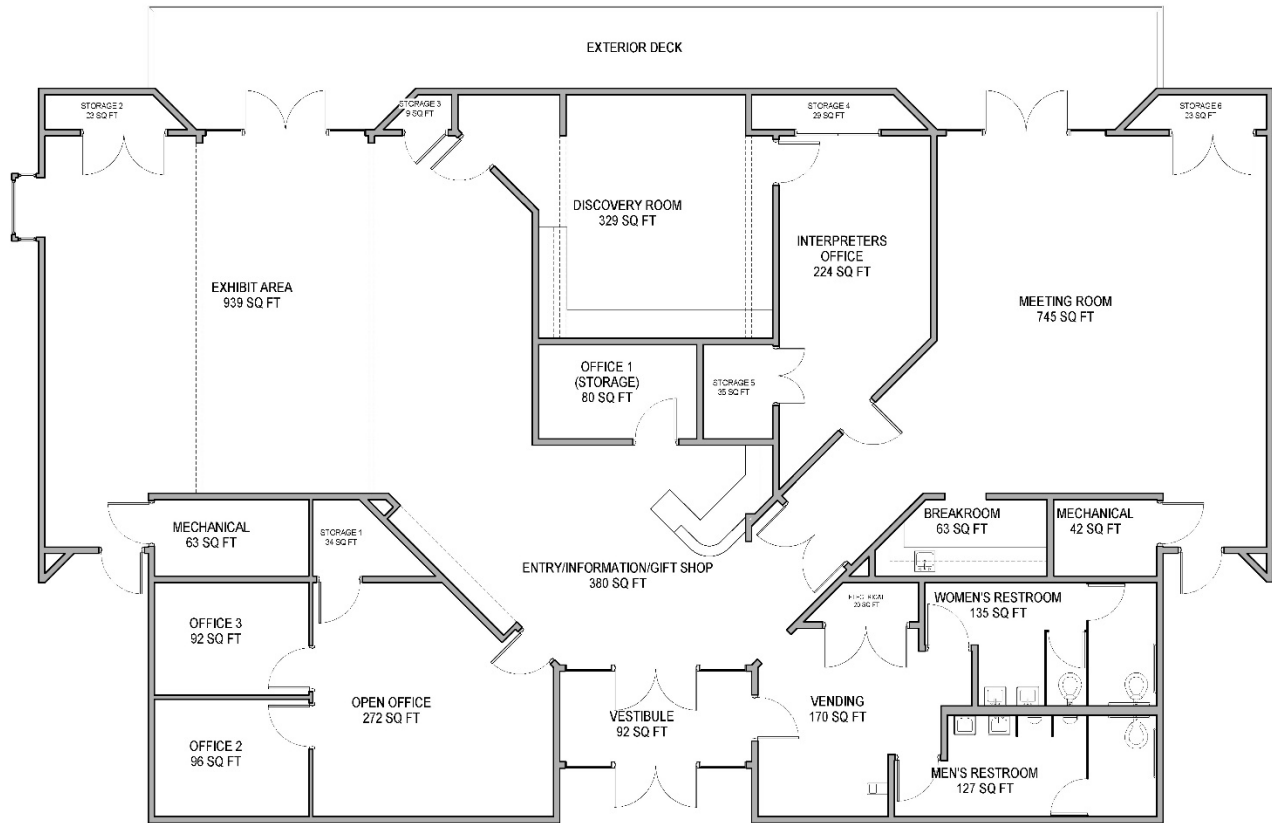
## Existing Conditions

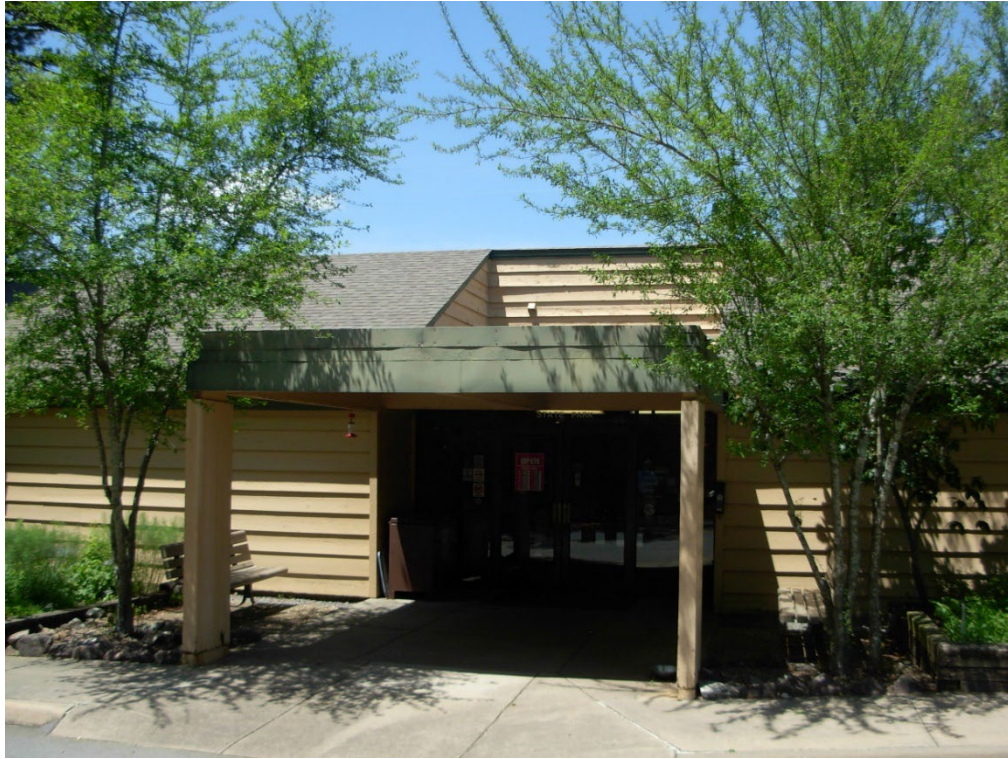
Photo 1: Front (South) Entry Overview. The wood siding is decayed and has been damaged by animals and insects. The metal fascia on the entry is warped. Owner noted drainage issues at flat roof.

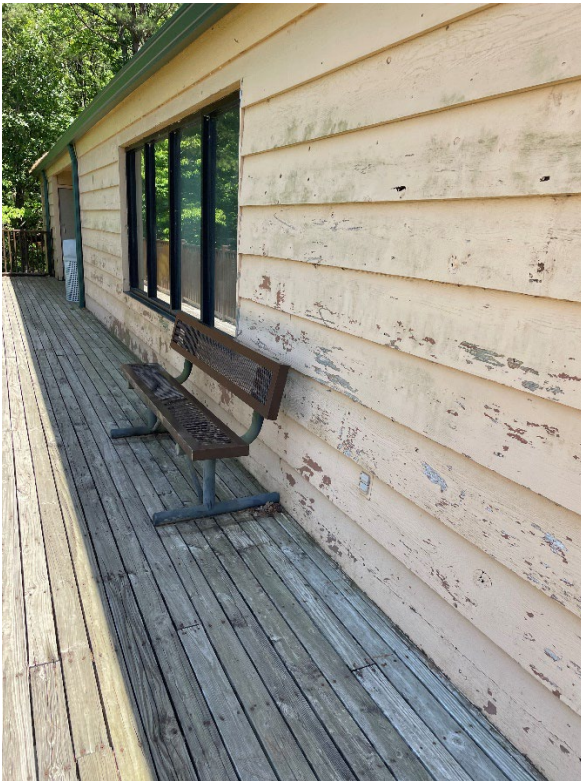
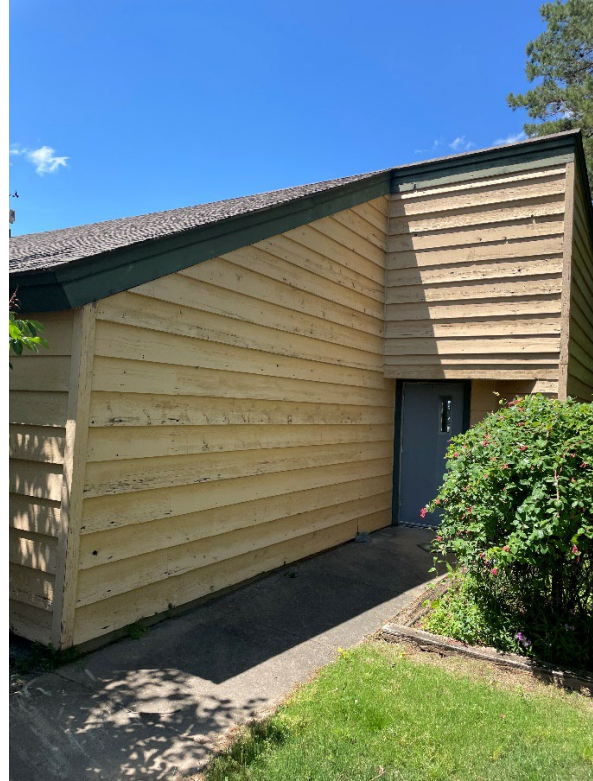
Photo 2: Siding at deck (North); Photo 3: Siding at East side of building. Wood (cypress) siding in need of replacement.

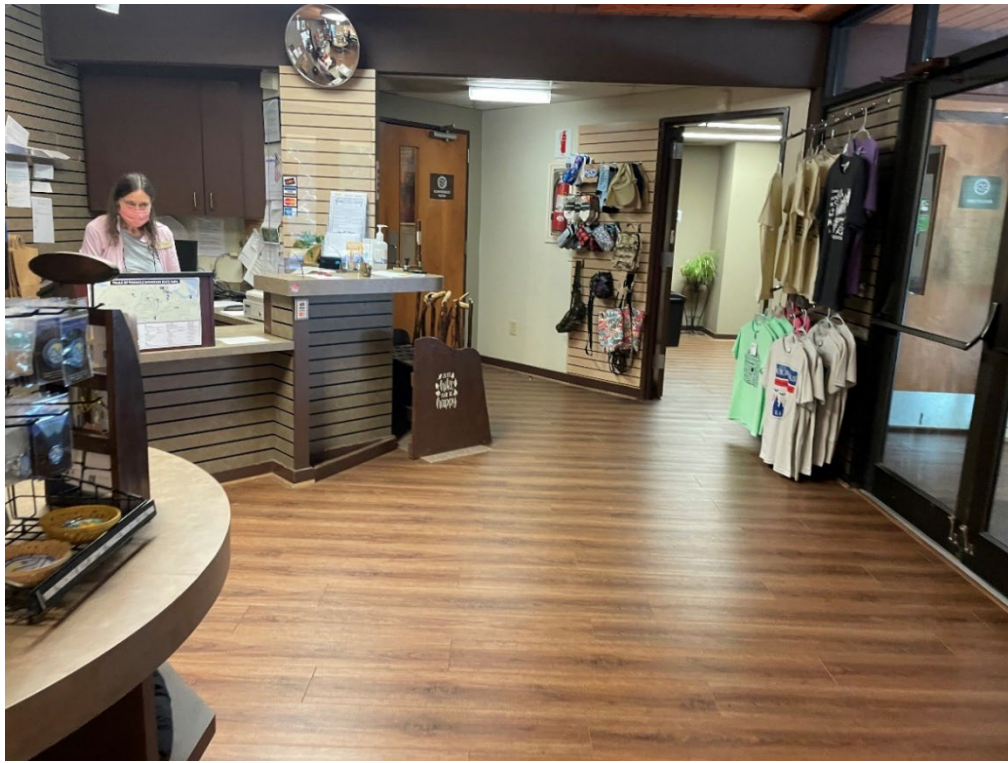
Photo 4: Entry/Information/Gift Shop Area. Single office space (currently used as storage), accessed from the information desk, includes mezzanine platform above. Office backs up to Discovery Room. Depending on new use of spaces, walls could be opened for view to the north when entering building, drawing visitors into the space.

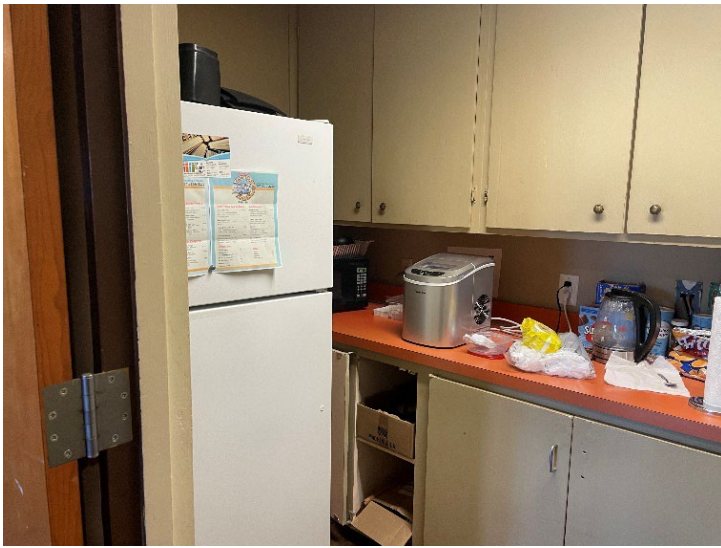
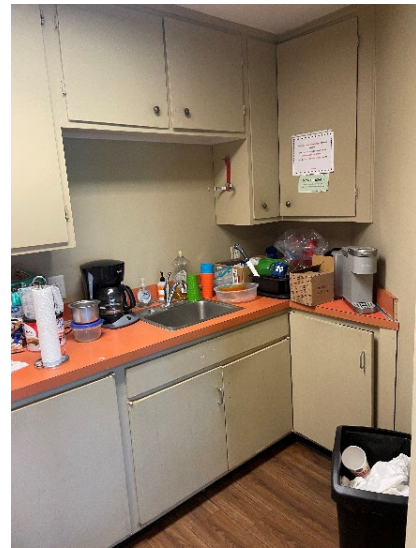
Photos 10 and 11: Small breakroom/kitchenette off Meeting Room. Owners noted GFI outlets not functioning.

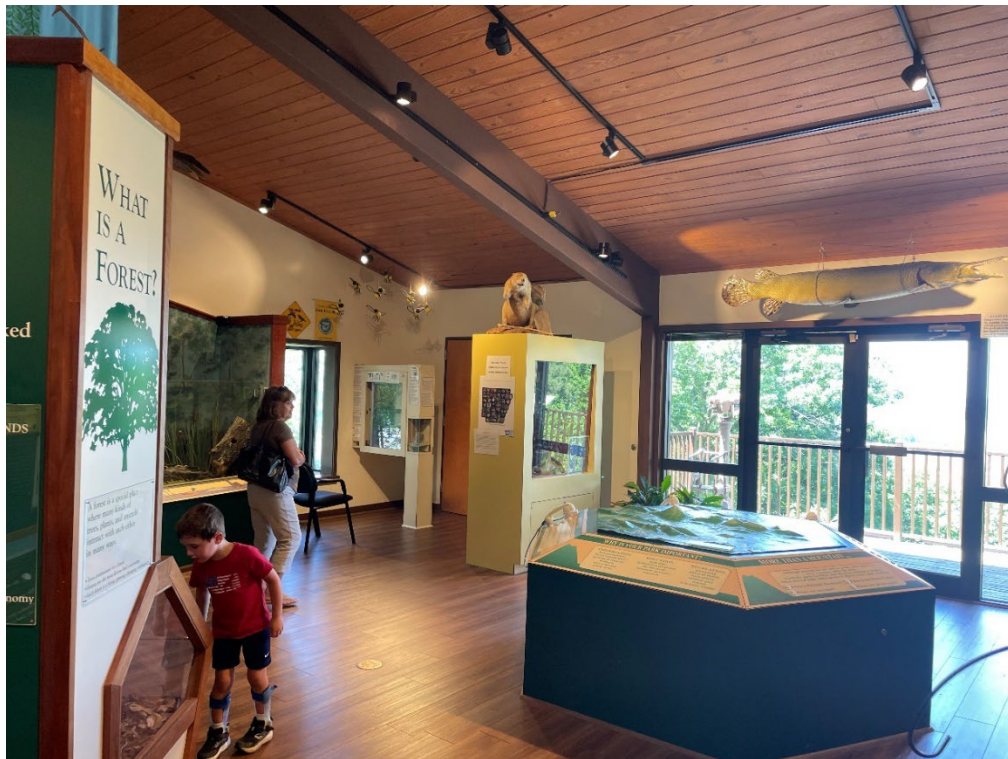
Photo 12: Exhibit Space with open ceiling/exposed glulam structure and decking.

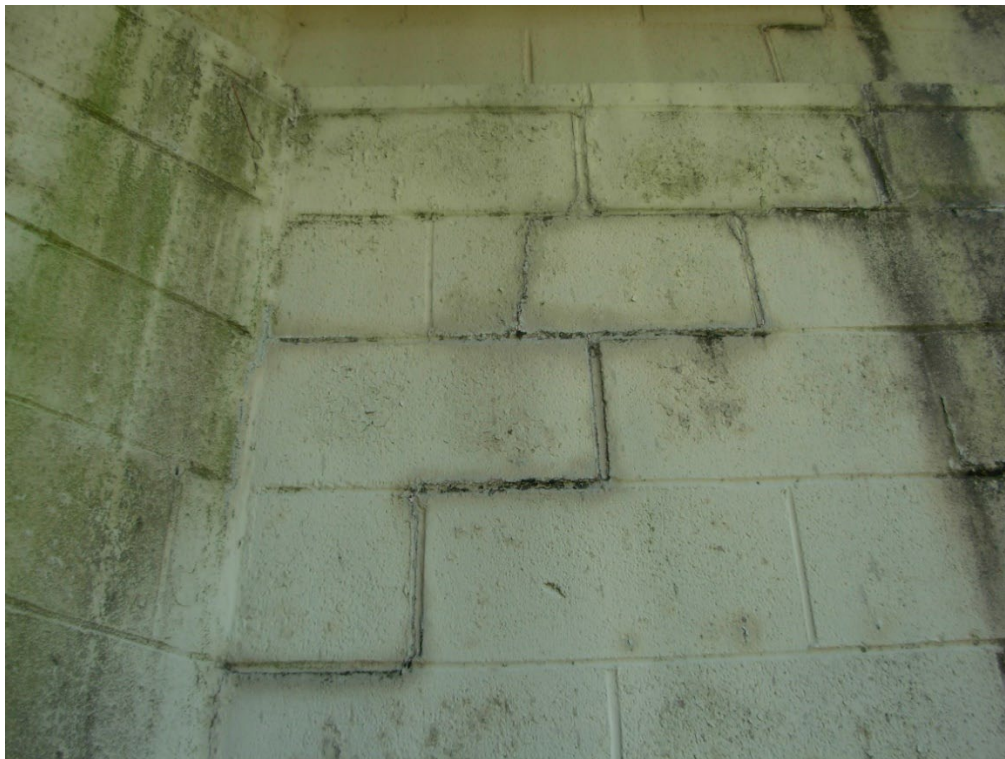
Photo 17: There are a couple of cracks in the concrete block stem wall in the Northwest corner. It appears there was some settlement shortly after the building was constructed, as these cracks were documented in 1992 and appear to be basically unchanged. I do not see these as a structural issue, unless the loading conditions of the walls are changed by any future improvements or adverse events.

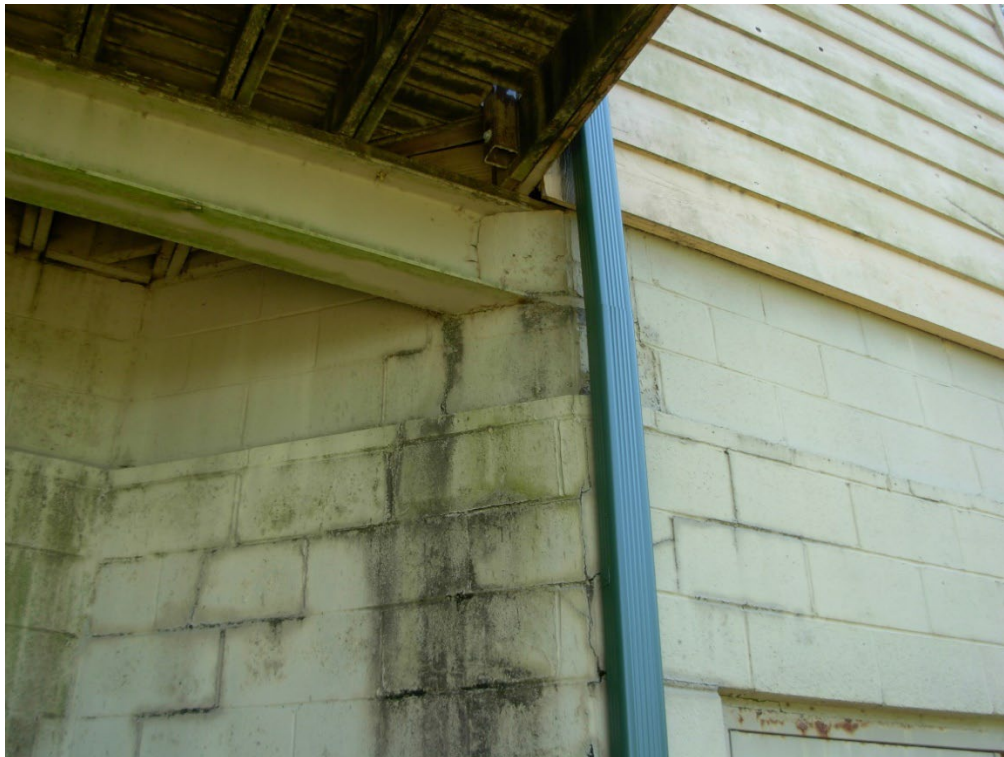
Photo 18: There are cracks and water streaking below the Northwest corner of the deck. There is a steel beam bearing on the concrete block that is adding some thermal expansion and contraction forces to the wall. This will need some attention if the deck is replaced or retrofit.

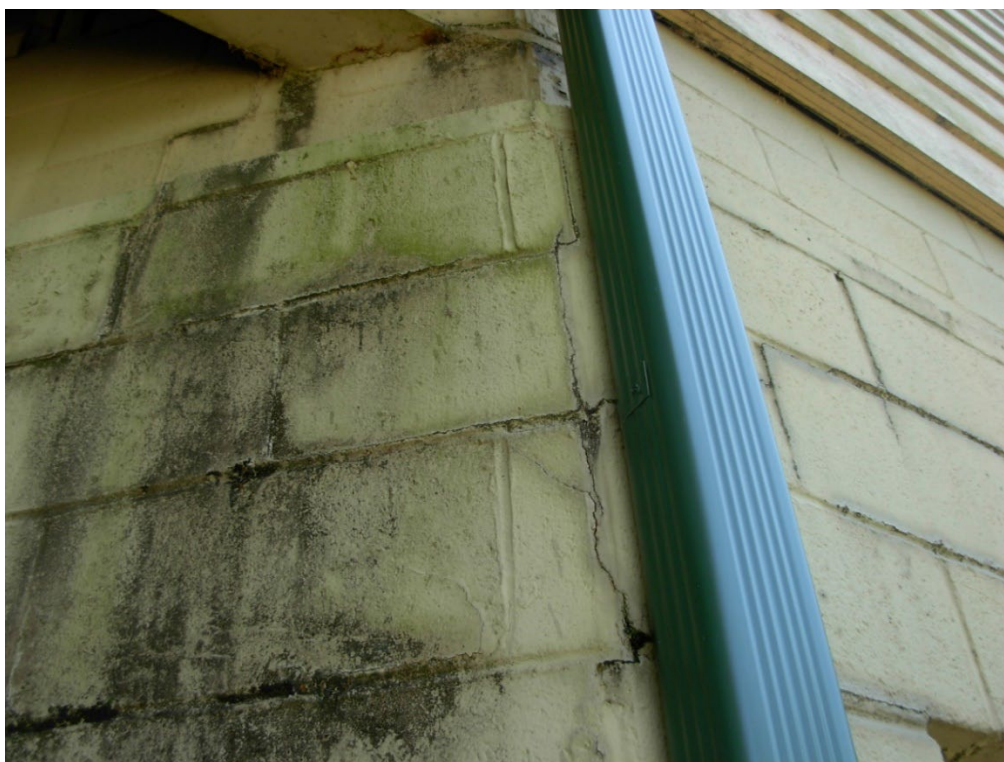
Photo 19: Close-up view of Northwest corner beam bearing. This looks worse than it is due to the water issues. The beam bearing and concrete block cracks are not in danger of failure.

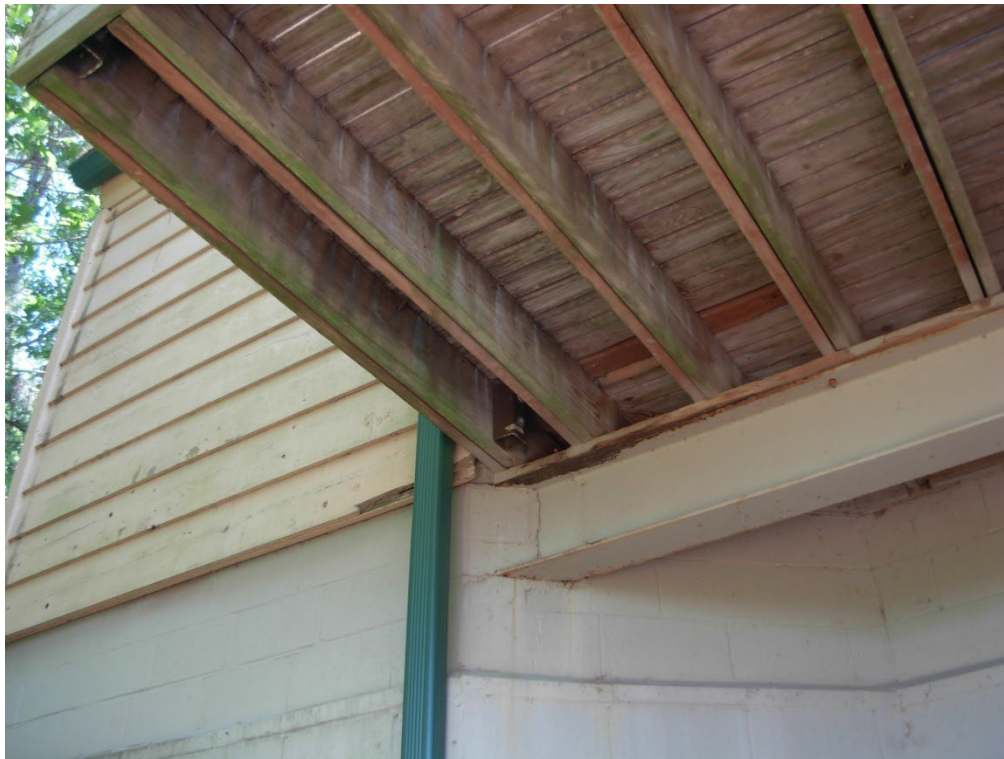
Photo 20: The steel beam bearing at the Northeast corner of the deck looks better.

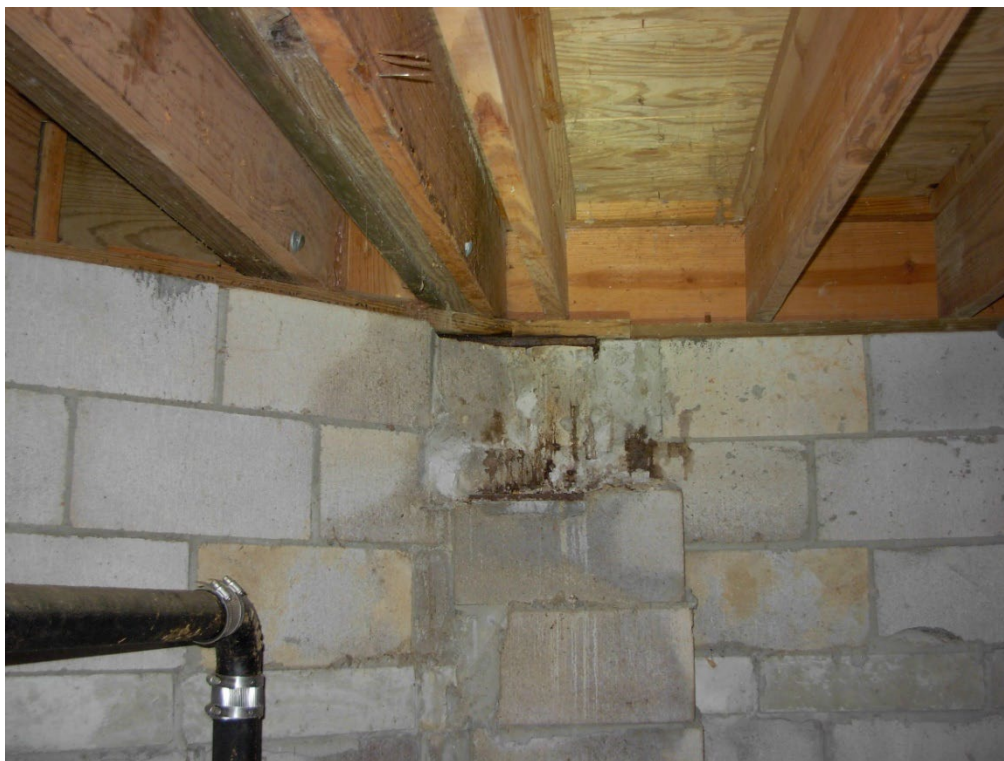
Photo 21: Overview of the steel beam bearing from inside the crawl-space. This condition looks rough, but structurally it is acceptable.

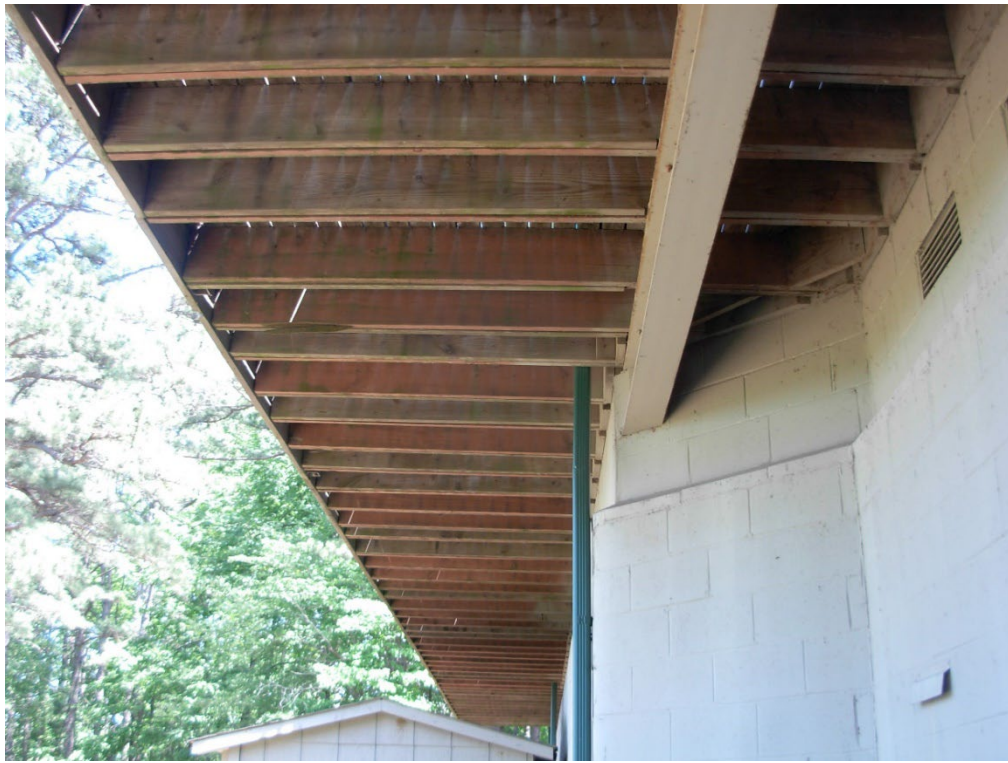
Photo 22: The back deck is cantilevered to the north and showing signs of age and weathering.

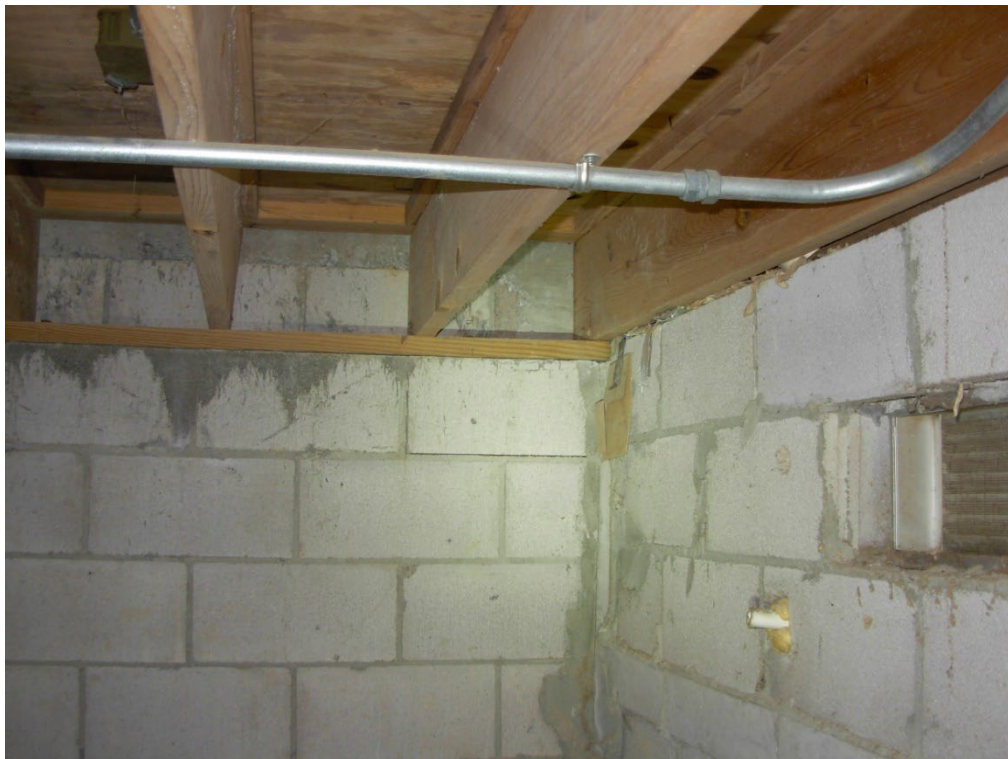
Photo 25: The concrete block foundation wall inside the crawl-space appears to be in acceptable condition, despite several mortar joint cracks.

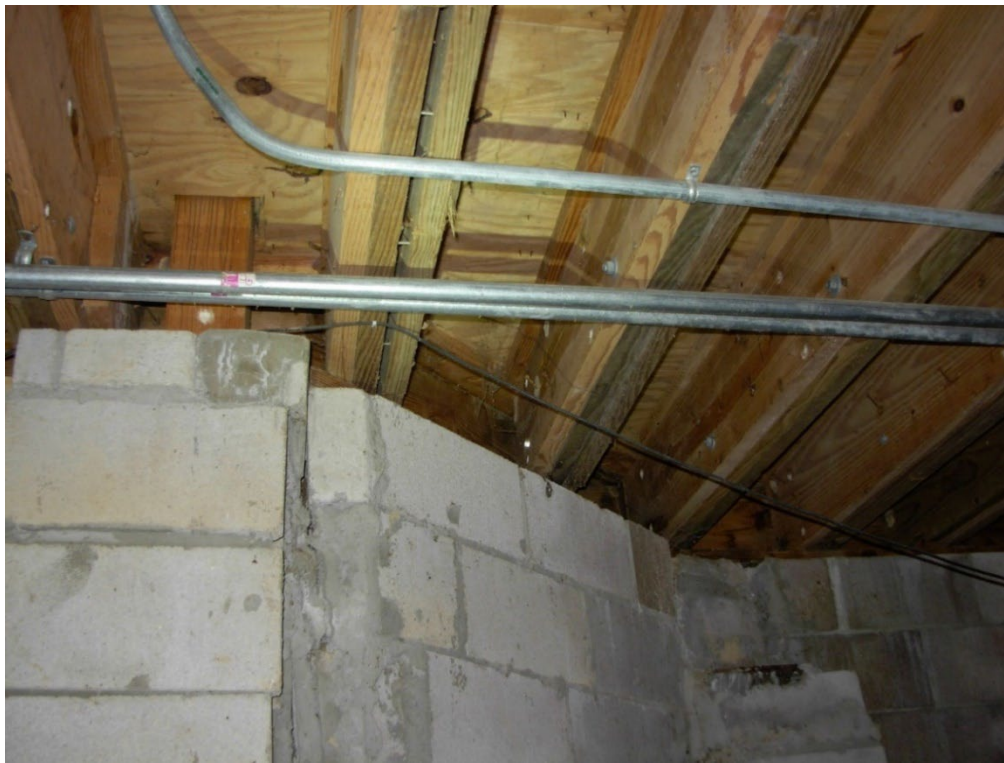
Photo 26: Crawl-space view of the back deck cantilever joists lap spliced to the floor joists. Some visible separation has occurred, but most of the members are in good shape. However, the deck likely needs to be replaced soon. I recommend cutting of the cantilevered joists and placing new exterior columns and beams at the outside edge of a new deck. This will allow the deck to be enlarged and have a higher load capacity.

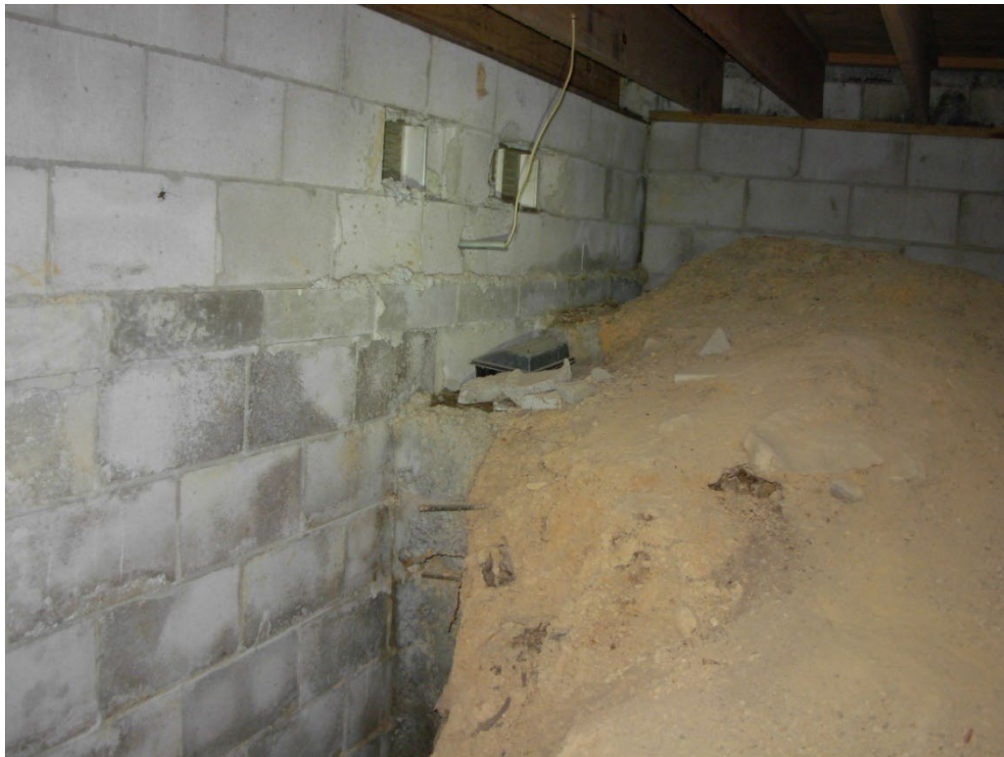
Photo 27: The East side foundation wall is in good condition. It has a large footing step that is exposed, but this too looks okay.

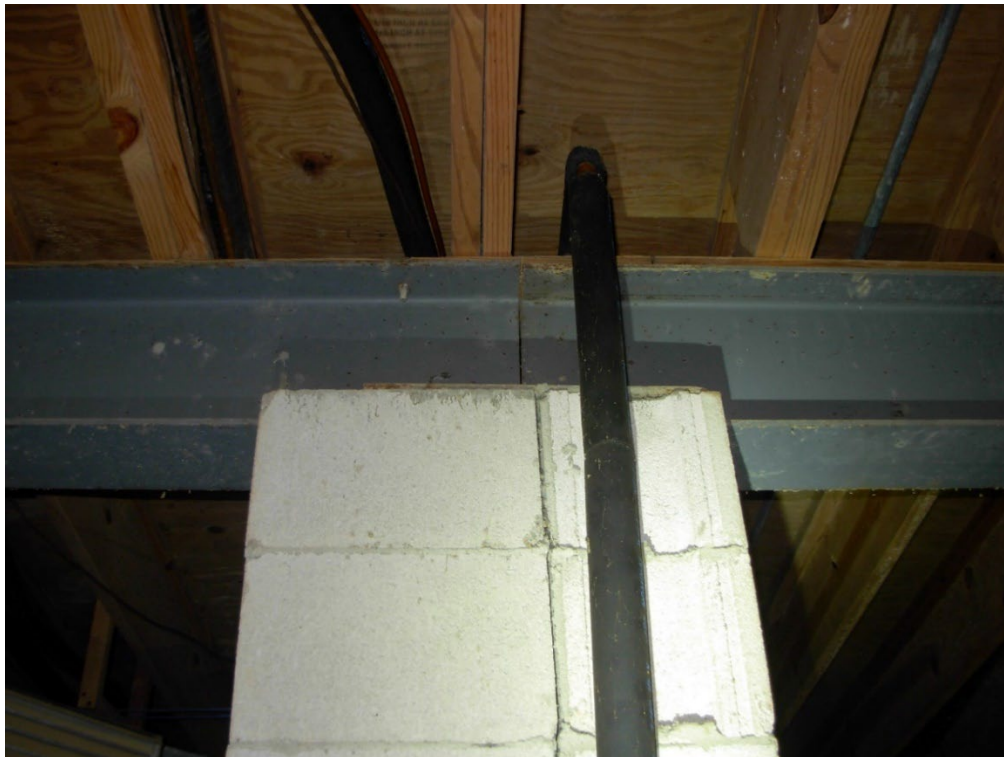
Photo 28: The floor girders in the crawl-space are steel beams bearing on concrete block piers. This condition is structurally acceptable and appears to be in good condition.

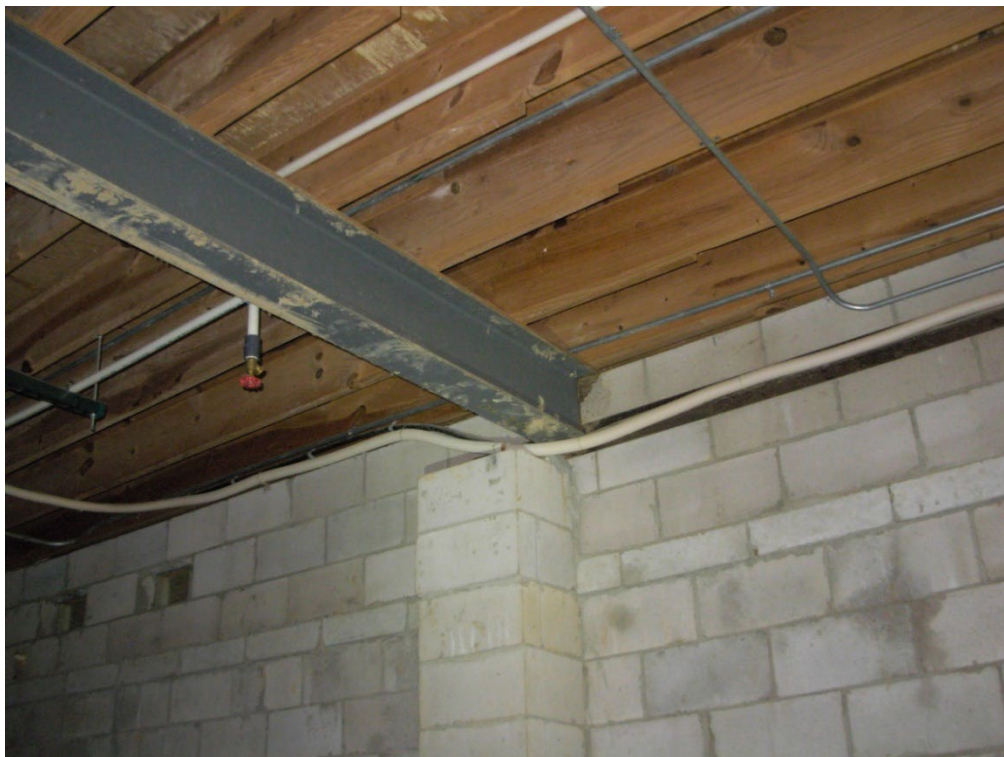
Photo 29: On the west end of the steel girder, the concrete block pilaster was apparently misplaced, so a steel angle was added to support the beam. This condition is not ideal but appears to be working.

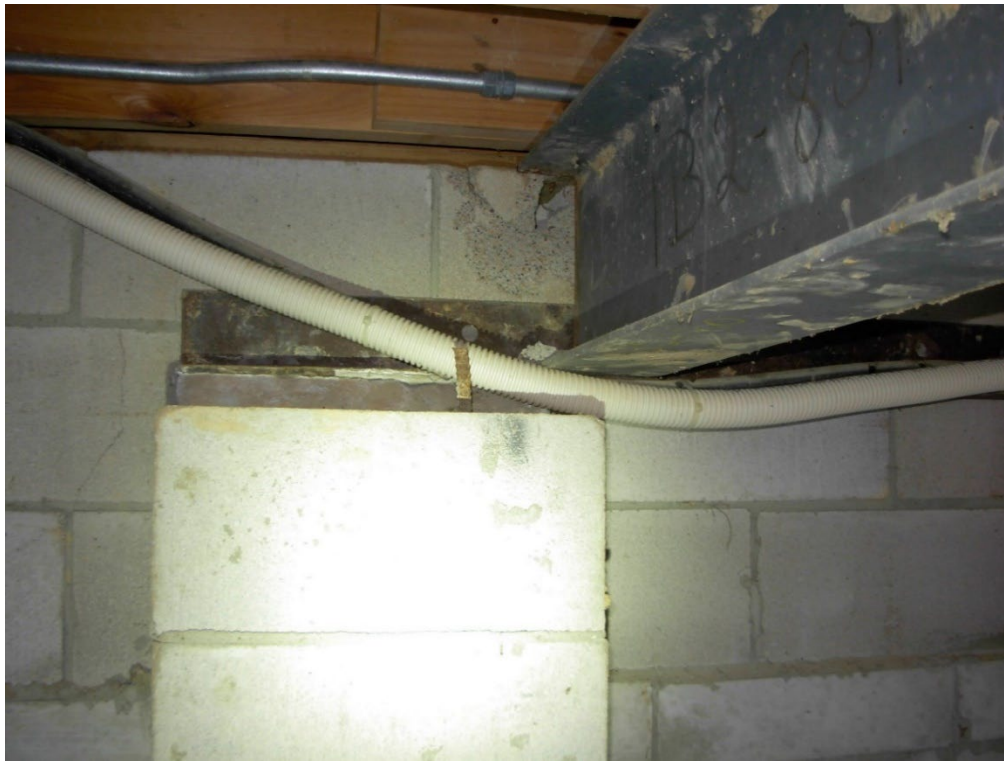
Photo 30: Close-up view of the steel girder bearing on the steel angle. The angle is bolted to the concrete block wall and bears on a grout bed on the pilaster.

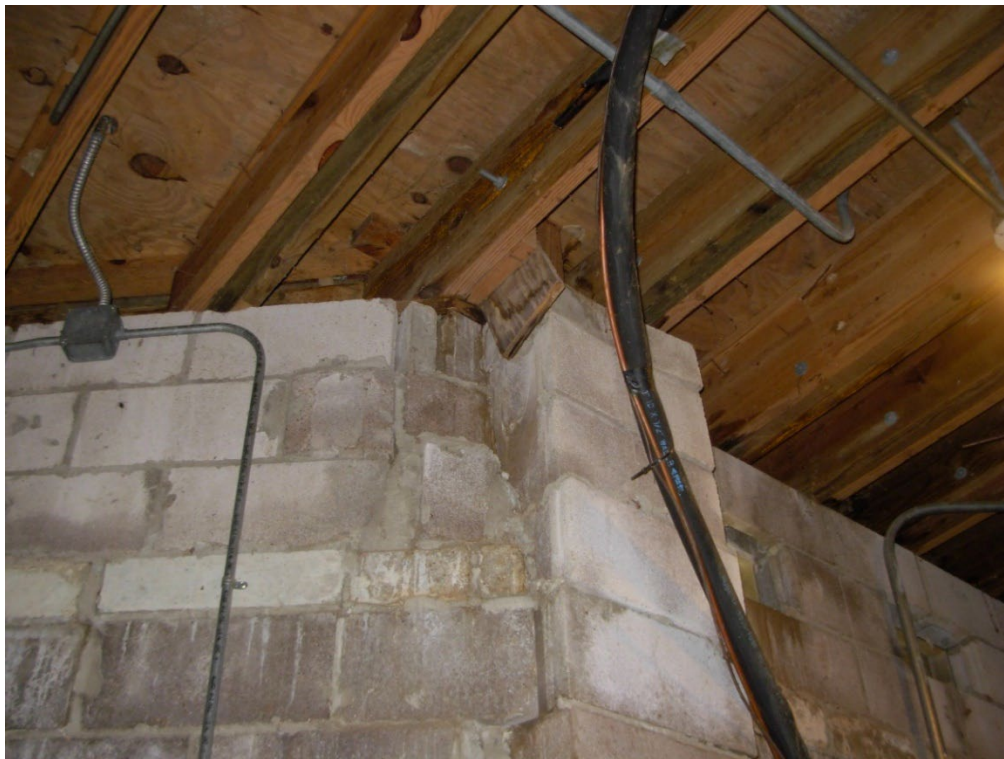
Photo 31: There is water damage to the wood decking along the back wall below the deck. If the deck is replaced, these areas need to be remediated with new wood and new flashing & waterproofing.

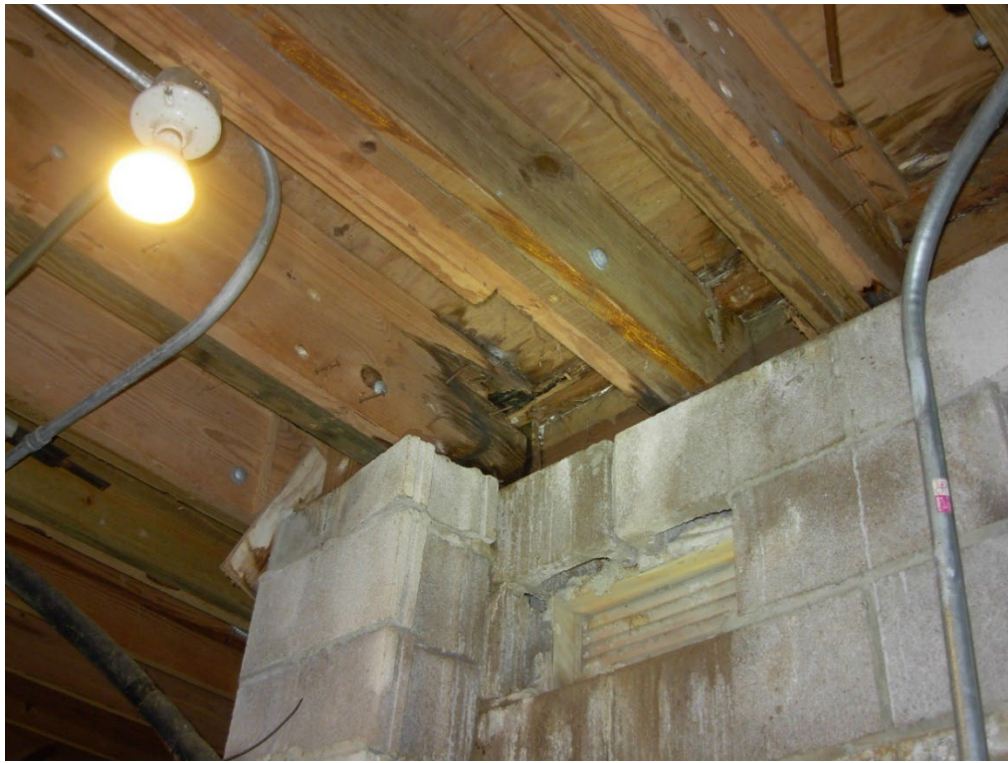
Photo 32: Water damage to the wood decking and floor joists at the back wall below the deck. This area has enough structural damage to be of concern of causing load support issues for the deck and back wall of the building and needs to be addressed ASAP.

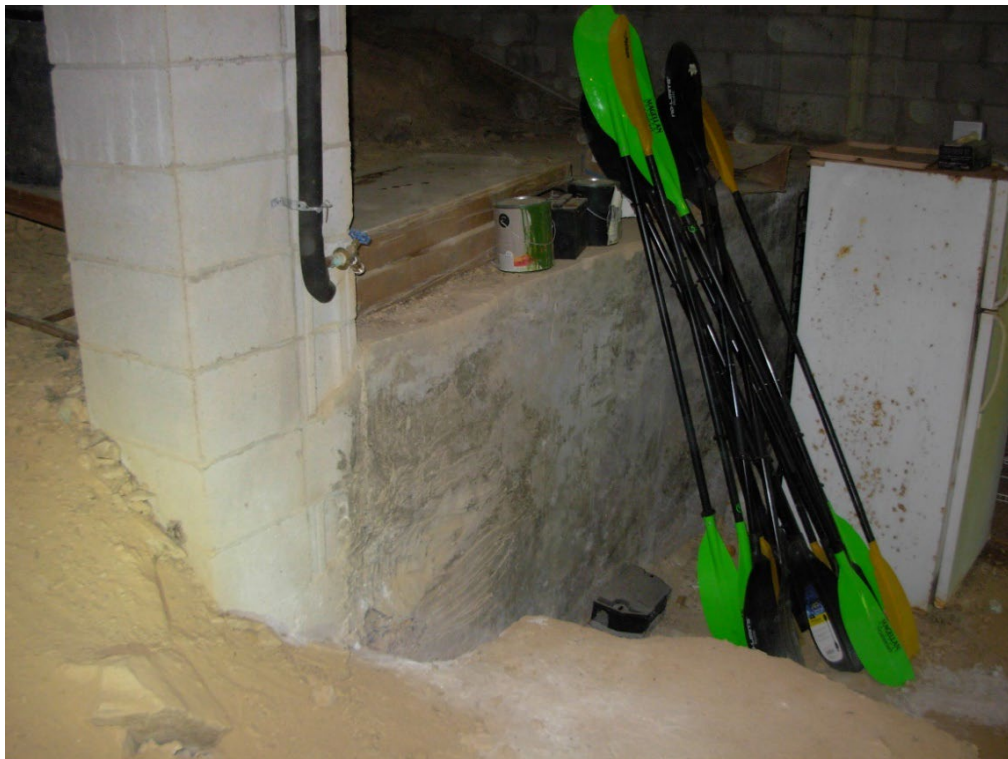
Photo 33: There is a concrete wall in the crawl-space that allows for a concrete pad in the Northwest corner. This wall is in good condition. The full length of the crawl-space could be similarly excavated and walled off to allow for more useable space, as desired.

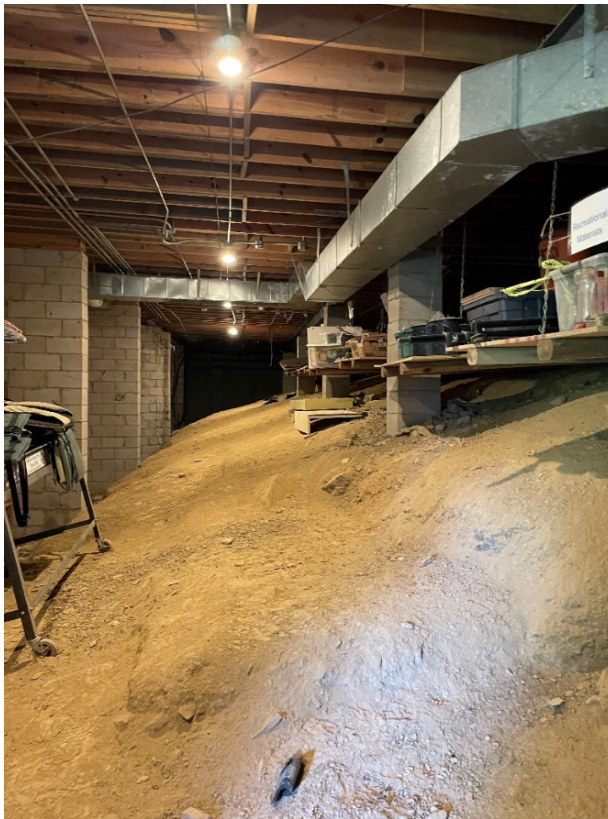
Photo 34: Overall view of north half of crawl space.

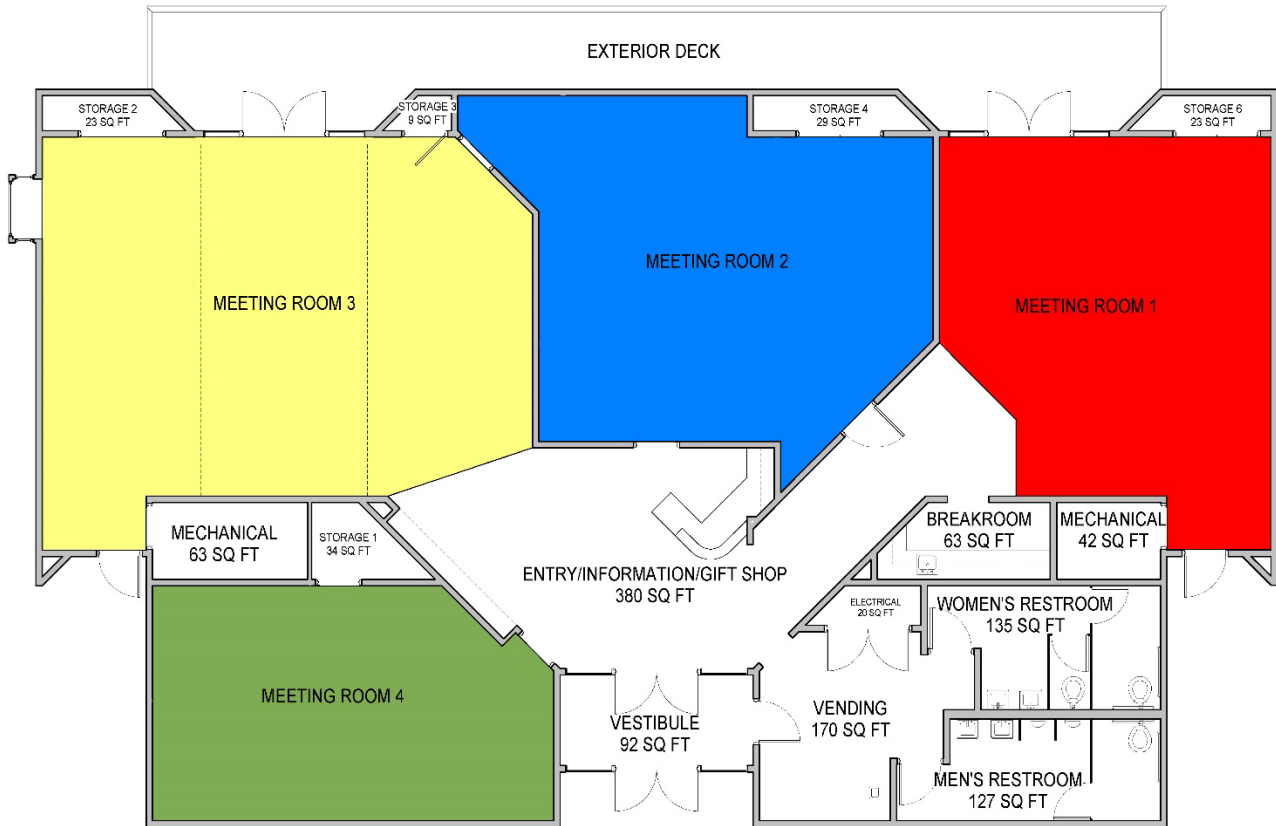
<b>Option 1 Recommended Renovations</b>		
Items	Budget	Notes
1. Repair of Water damaged structure	\$ 10,000.00	
2. Roof + fascia replacement at flat roof	\$ 5,500.00	Approximately 400 sq ft

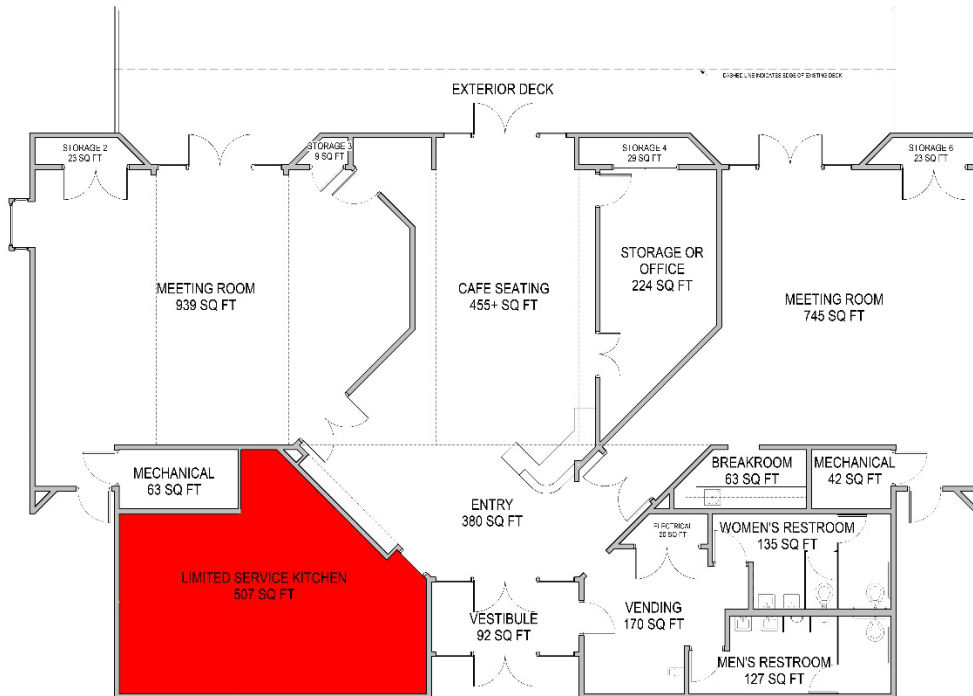
**Option 2 – Version C** shows kitchen at southwest corner of building, allowing central space to be opened for seating area and view to overlook visible upon entering the building. This kitchen location is on slab foundation and would require trenching (increase in price vs options over crawl space)

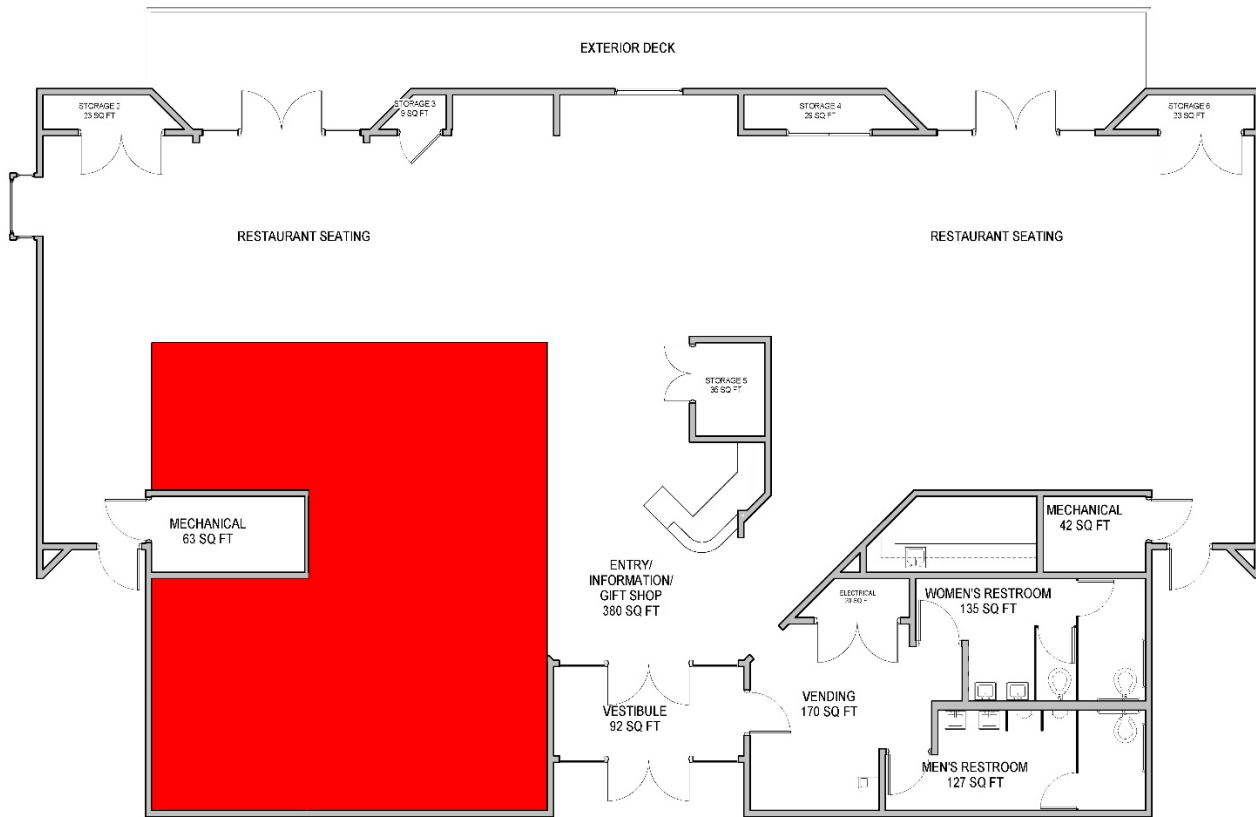
<b>Option 3 Recommended Renovations</b>		
Items	Budget	Notes
1. Items 1-5 + 9-14 from Option 1	\$ 347,500.00	
2. 1,000 sq ft kitchen	\$ 65,000.00	
3. Kitchen equipment	\$ 125,000.00

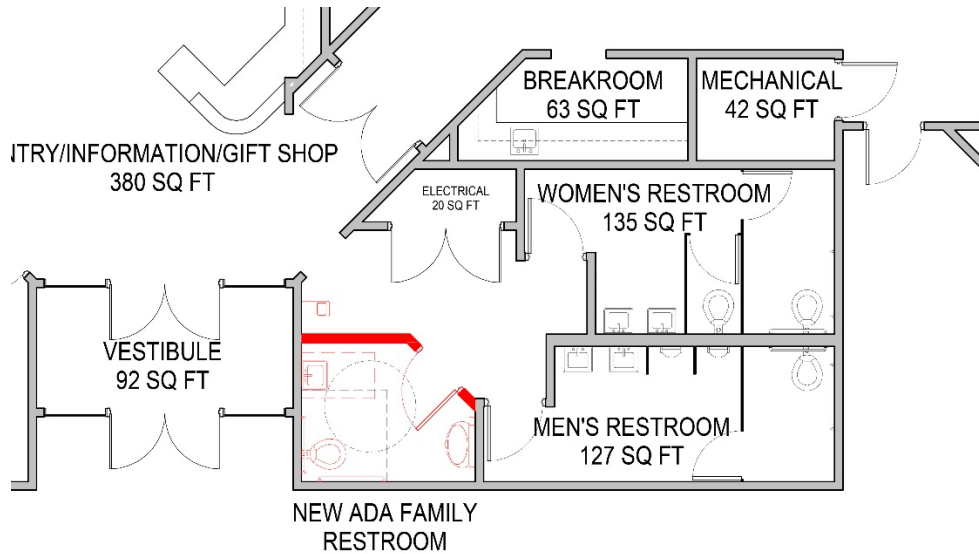
ADA Family Restroom		
Items	Budget	Notes
1. Limited Demo and New Walls	\$ 1,000.00	Approximately 170 sq ft \$3.33
2. New Ceiling	\$ 1,000.00	Approximately 170 sq ft \$5.625
3. New Flooring	\$ 2,550.00	Approximately 170 sq ft \$15
4. Interior Painting	\$ 500.00	
5. Mechanical, Electrical, Plumbing	\$ 25,000.00	Includes trenching
Subtotal	\$ 30,050.00	
GC Overhead – 10%	\$ 3,005.00	
GC Profit – 10%	\$ 3,005.00	
Contingency – 10%	\$ 3,005.00	
<b>Total</b>	<b>\$ 39,065.00</b>	<b>\$230/sq ft</b>
